32 SECONDS...

Analysis of the accident of an Atlas Air B-767-300 (cargo) operated for Amazon.com Services LCC at Trinity Bay, Texas, in February 2019.

Mach82 N°209

Francisco Cruz - Sepla Technical Department

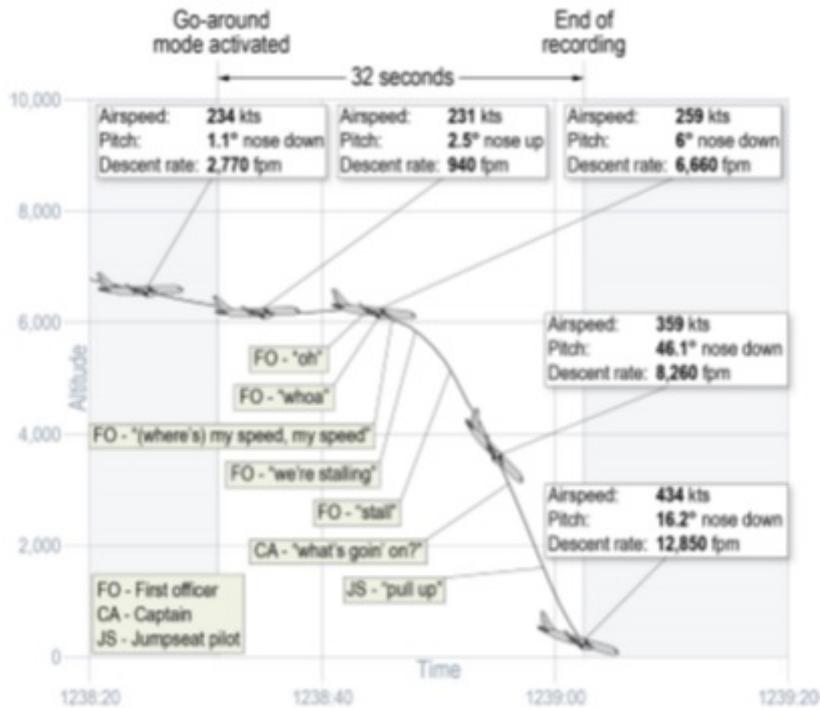
Figure 1. Selected airplane parameters and crew statements during final seconds of flight.⁸

3) At 12:38:56, the captain asks "what's goin'on". 3 seconds later, the pilot sitting in the carrier shouts "pull up". At that time, the elevators move with nose-up inputs, which last 7 seconds, insufficient to counteract the steep descent of the aircraft (see figure 1 of the report). The aircraft impacts the ground at high speed at 12:39. The top of the cloud ceiling was between 2000 and 3000 ft AGL.

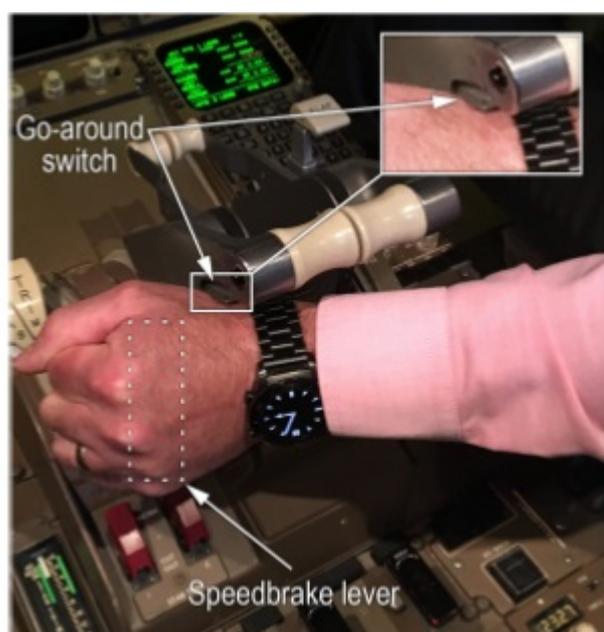
1) In approach phase below 10000 ft AMSL and descending, the co-pilot was actuating the speedbrakes and asked the captain for flaps 1 (slats extension). Probably due to the light turbulence at that time, the co-pilot's wrist or watch accidentally activated the Go Around gas mode switch. This occurs at 12:38:31.

Figure 12 of the report showing the interaction between the co-pilot's left wrist with the

"Go Around" mode switches.
