**INCIDENT**

<b>Aircraft Type and Registration:</b>	Airbus A321-231, G-WUKG	
<b>No &amp; Type of Engines:</b>	2 International Aero Engine V2533-A5 turbofan engines	
<b>Year of Manufacture:</b>	2018 (Serial no: 8236)	
<b>Date &amp; Time (UTC):</b>	16 January 2020 at 1925 hrs	
<b>Location:</b>	London Luton Airport, Bedfordshire	
<b>Type of Flight:</b>	Commercial Air Transport (Passenger)	
<b>Persons on Board:</b>	Crew - 7	Passengers - 157
<b>Injuries:</b>	Crew - None	Passengers - None
<b>Nature of Damage:</b>	None	
<b>Commander's Licence:</b>	Airline Transport Pilot's Licence	
<b>Commander's Age:</b>	32 years	
<b>Commander's Flying Experience:</b>	8,305 hours (of which 5,175 were on type) Last 90 days - 97 hours Last 28 days - 42 hours	
<b>Information Source:</b>	Aircraft Accident Report Form submitted by the pilot

**Synopsis**

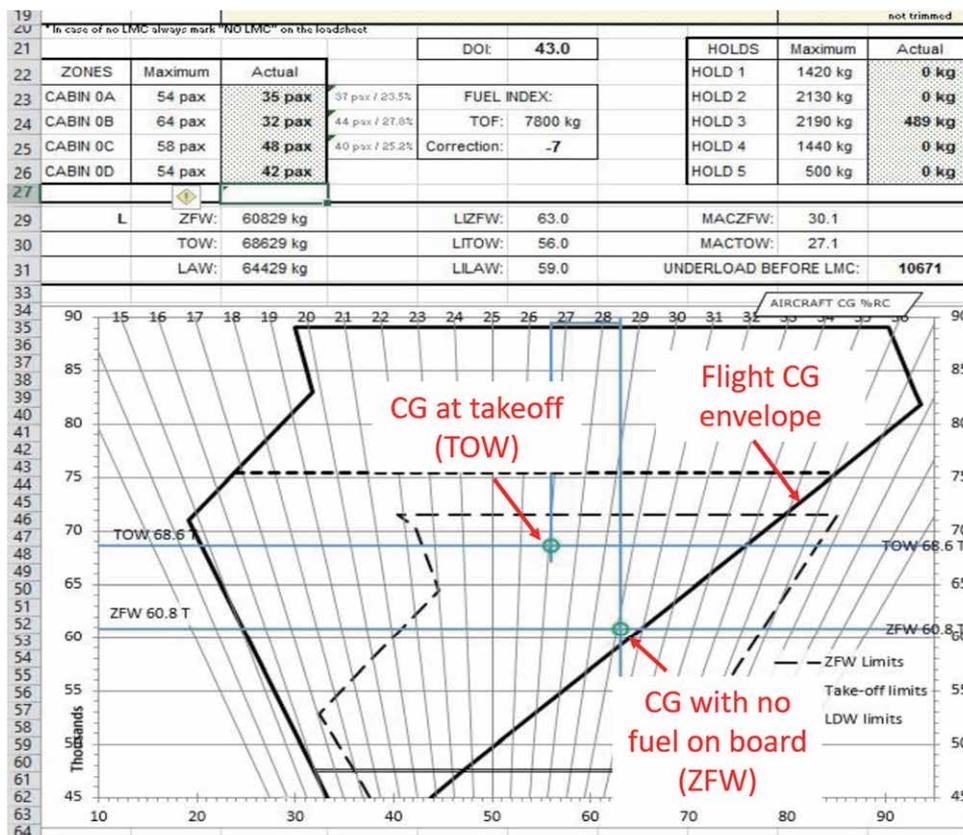
Figure 1

On the day of the incident, an A320 was allocated to the flight and this information was passed to OHD and PSD at Luton. Both departments received the information and began their respective activities towards producing a Load and Trim Sheet and checking in the passengers for an A320. Later, the OCC needed to change aircraft from the A320 to G-WUKG, an A321. An email informing OHD and PSD of the change was prepared but, due to a technical problem, was not sent. This was noticed later in the day, at 1405 hrs, and the OCC Duty Manager telephoned the OHD and informed them of the aircraft change. The OHD entered the new aircraft registration into the Load and Trim Sheet software but PSD were not informed and had already allocated passenger seating for the three passenger zones on the original A320. When all the passengers had passed through the boarding gate and taken their allocated seats for the A320, the software produced a Load and Trim Sheet with passenger distribution for the four zones of the A321, maintaining the CG within limits for the flight. This sheet was passed to the flight crew and is shown below at Figure 1.

The Load and Trim Sheet as calculated but not as loaded

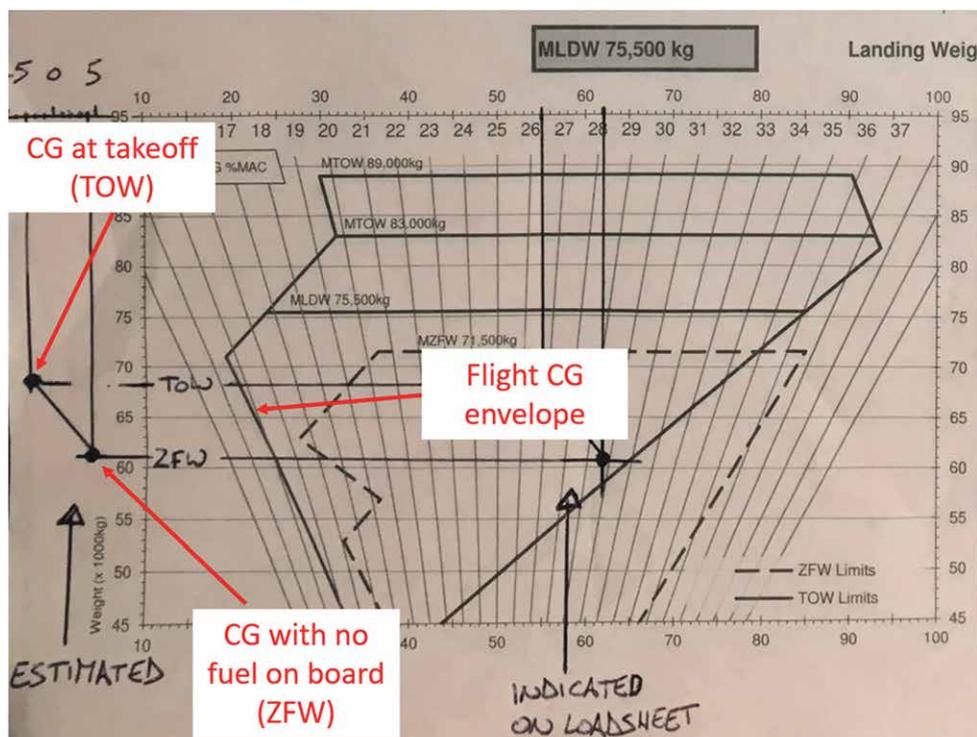
Figure 2

After the incident, the commander completed a Load and Trim sheet using the passenger seating allocation for the A320, but with the passengers seated in those seating positions in G-WUKG. The result, shown in Figure 2, shows that the total passenger weight was forward in the cabin placing the aircraft CG outside the permitted envelope.

The A321 Load and Trim Sheet that would have resulted on the incident flight

The incident occurred due to the aircraft change from an A320 to an A321 not being notified to both OHD and PSD. As a result, the passengers were seated at the front of the aircraft, placing the CG outside the forward limit of the operating envelope. The effect of this was that, at rotation, the aircraft appeared to the crew not to respond as expected to the normal side stick control inputs due to the forward CG. The PF required almost maximum aft control input and the PM selected TOGA thrust before the aircraft nose lifted. The crew analysed the problem but considered that an incorrect stabiliser setting, taken from the load sheet, had caused the problem. Only at the top of the descent for the destination did it become apparent that the passengers had possibly been incorrectly distributed in the cabin. The crew did not experience any unusual control response during the approach and landing.

- Improve the passage of information between the OCC and the flight crew when a change of aircraft variant takes place.
- Improve Ground Handling Agents' awareness of the implications of a change in aircraft variant.
- Distribute and make highly visible to all staff briefing material on this incident.
- Include any variant change at the flight and cabin crew briefing.
- Provide additional training for cabin crew on weight and balance distribution and its affects.
- Produce a Safety Bulletin to provide staff with a more detailed description of the incident.
- Issue a Crew Order (change to Operations Manual Part A) with enhanced awareness and guidance if suspicion is raised onboard.
