SERIOUS INCIDENT

Aircraft Type and Registration:	Airbus A320-216, EC-KLT
No & Type of Engines:	2 CFM56-5B6 turbofan engines
Year of Manufacture:	2007 (Serial no: 3376)
Date & Time (UTC):	26 August 2019 at 1205 hrs
Location:	On approach to Birmingham Airport
Type of Flight:	Commercial Air Transport (Passenger)
Persons on Board:	Crew - 6 Passengers - 189
Injuries:	Crew - None Passengers - None
Nature of Damage:	None
Commander's Licence:	Airline Transport Pilot's Licence
Commander's Age:	40 years
Commander's Flying Experience:	9,700 hours (of which 8,080 were on type) Last 90 days - 150 hours Last 28 days - 61 hours
Information Source:	AAIB Field Investigation

Synopsis

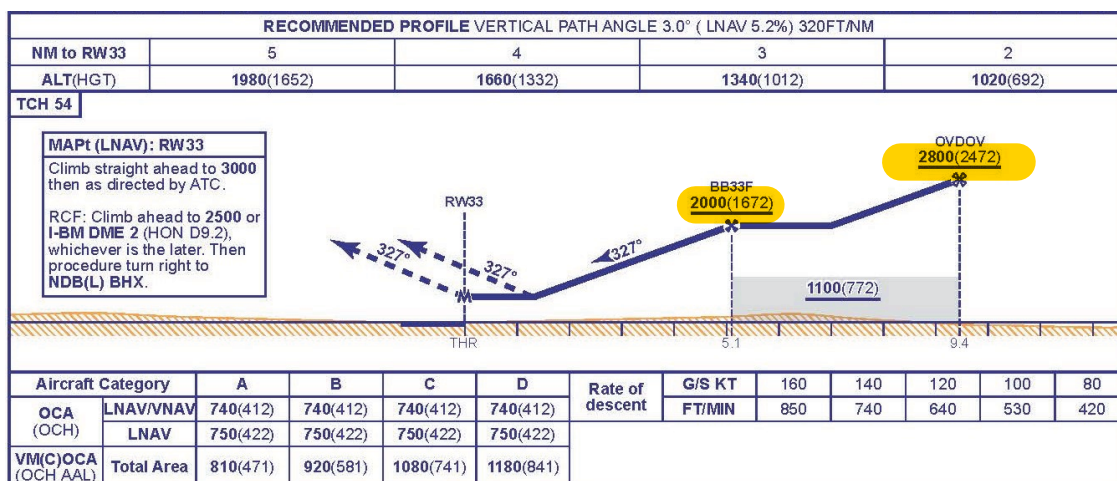
Figure 1

The aircraft was at 4,000 ft approximately 11 nm south of the airport when ATC cleared it to descend to 2,000 ft and carry out the RNAV approach (Figure 1). The pilots read back the clearance correctly but, thirty seconds later, the aircraft had not changed altitude and they contacted ATC to request descent. ATC again cleared the aircraft to descend to 2,000 ft and to carry out the approach. The aircraft was 10.5 nm from the runway when it started descending. At 9.4 nm it was at 3,800 ft, 1,000 ft above the correct profile.

Vertical profile of RNAV approach to Runway 33 at Birmingham Airport
(Extract from UK Aeronautical Information Publication)

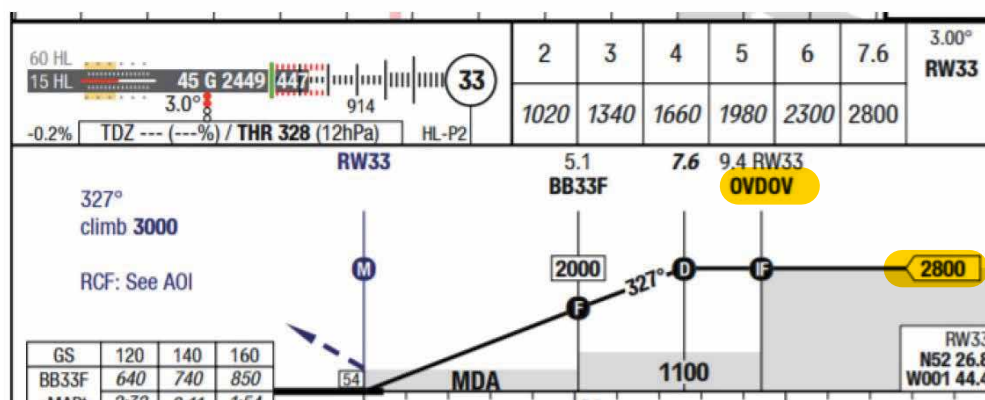
Figure 2

The investigation also highlighted a difference between the descent profile for the RNAV approach published in the UK AIP⁵ and that published by the operator's chart provider⁶. Whilst the former had a platform altitude for the approach of 2,000 ft with final descent starting at 5.1 nm from the threshold, the operator's approach charts showed a continuous descent starting from 2,800 ft at 7.6 nm (Figure 2). This led to confusion by the pilots when initially they were cleared to 2,000 ft on the first approach, causing them to delay their descent and to ask ATC again for the descent instructions. This had served to compound the issue of the late configuration of the aircraft for the approach whilst trying to slow down, resulting in the aircraft not establishing on the correct approach profile and leading to the missed approach.

Extract from operator's chart for RNAV approach to Runway 33 at Birmingham

The aircraft did not maintain the correct vertical profile because the pilots were not sure when to commence the final descent. The depiction of the descent profile on charts provided by the operator may have contributed to this uncertainty.

Different chart providers have different ways of depicting approach profiles. However, the AIP remains the source document and ATC will naturally rely on this, rather than individual operator's charts, when managing air traffic. Where differences exist, it is desirable for operators and ATC to ensure their effect is understood.
